TCI6636K2H

Multicore DSP+ARM KeyStone II SOC

Silicon Revisions 1.0, 1.1, 2.0, 3.0, 3.1

Silicon Errata

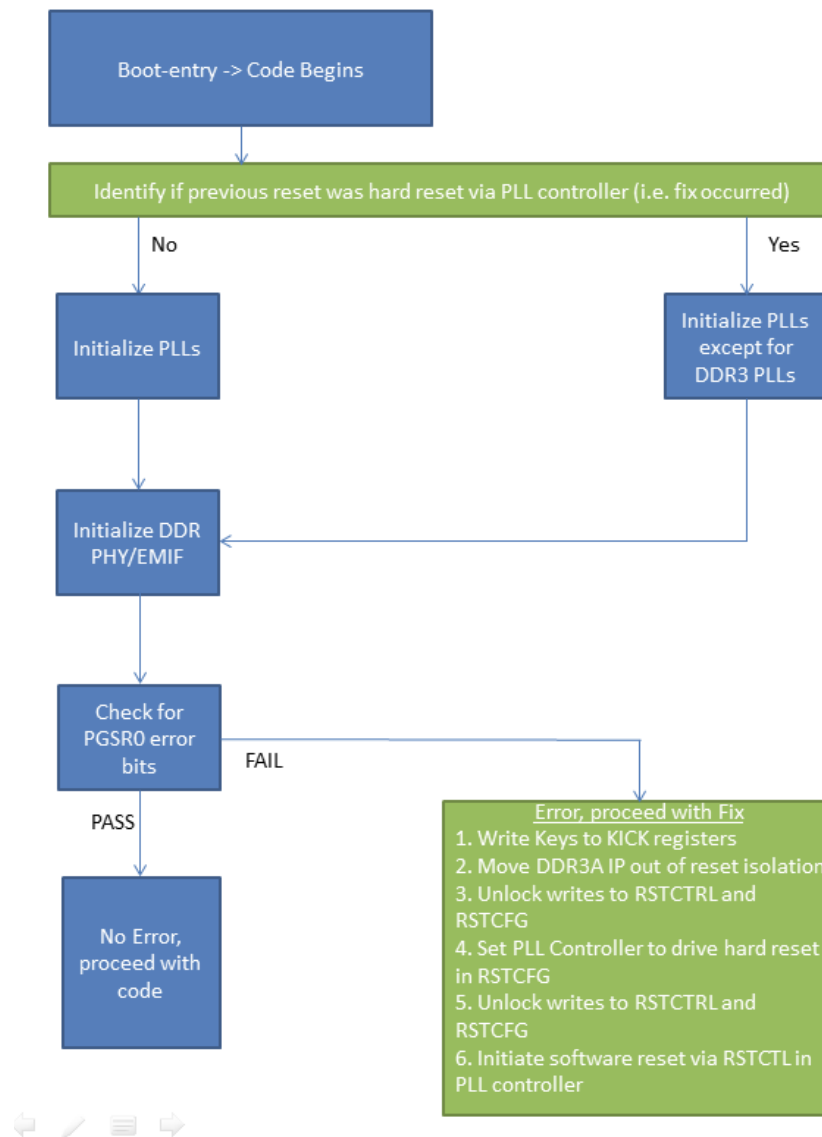
Figure 3. Software Reset Using the RSTCTRL Register

The root cause is identified to an issue that happens after the very first DDR3 PHY initialization, this first initialization happens directly from Power-on reset. The issue occurs because the clocking requirements of the DDR3 PHY are not met on the first initialization, this happens because the DDR3A and DDR3B SoC PLLs are not yet programmed to provide the requisite clock. There is a ratio requirement between the DDR3A/B PHY clocks and the core configuration clock, such that the core configuration clock must be less than or equal to the PHY clock. These clocks are asynchronous and the PHY support an asynchronous FIFO scheme with limited depth on the PHY clock domain. If the ratio requirement is not met then FIFO can overflow. This would mean that the configuration data for the PHY may be lost during the initialization sequence. Experiments have proven that if we apply Hard Reset once the clocking has been set up correctly, the issue is resolved.

BLUE colored blocks show the normal execution while the GREEN colored blocks show the changes. The “Error, proceed with Fix” block is the block which explains the steps that need to be followed to apply the Software Reset using RSTCTRL register. The steps are mentioned for DDR3A. The same steps need to be used for DDR3B also.

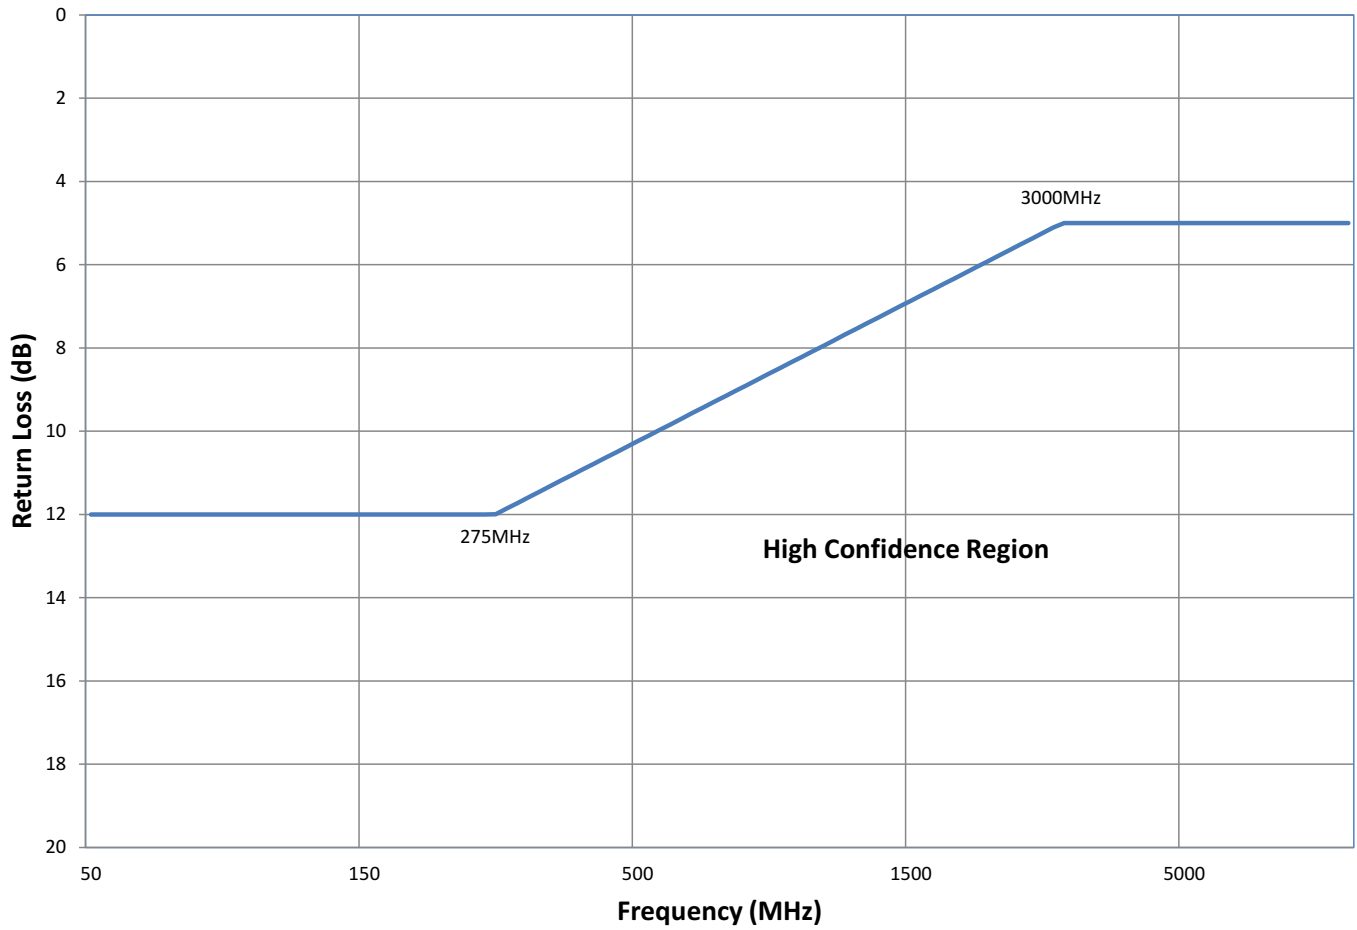
Device characterization has also shown that channels should be compliant with the Return Loss template shown below. The Return Loss measurement indicates the amount of energy reflected back to the source which is not available to the receiver. Impedance variation in the channel will cause reflected energy that can cause this template to be violated. Careful attention to PCB construction and layout must be followed to meet this requirement. This template must be met for the entire channel from transmitter to receiver including the series capacitors. Note that this is the same template

defined in IEEE 802.3-2008 Annex 69B specification for 10GbE.

Workaround None.

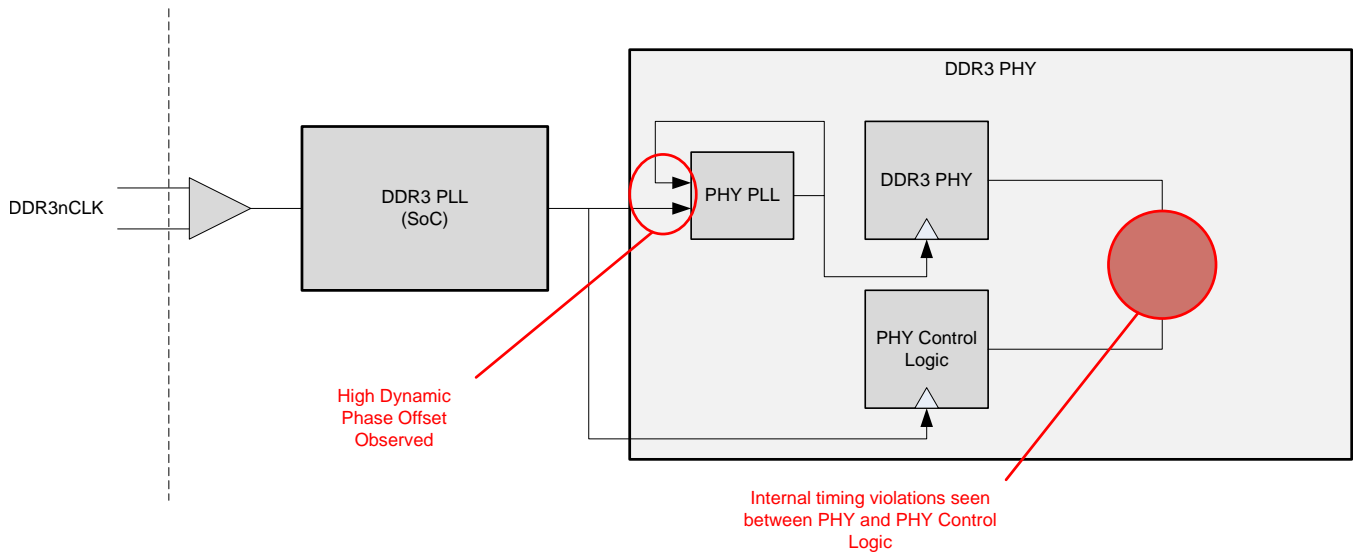
Figure 6. DDR3 PHY

DDR3 read operations may show errors due to increased levels of Dynamic Phase Offset (DPO) inside the DDR3 PHY. These errors are characterized by byte lane data corruption or intermittent bit errors. The byte lane data corruption can only be recovered using a device reset.

The Dynamic Phase Offset (DPO) is a measure of the DDR3 PHY PLL’s ability to track rapid phase changes in the output of the DDR3 SoC PLL. High DPO can create internal timing violations between the DDR3 PHY and DDR3 PHY Control Logic and result in data errors during reads. As indicated by the shaded red circle in the figure above, the timing violations occur in the data transfer between the PHY and PHY control logic. It was determined that the root cause of the elevated DPO were SoC PLL and PHY PLL configurations that were non-optimized for the timing requirements of the system.

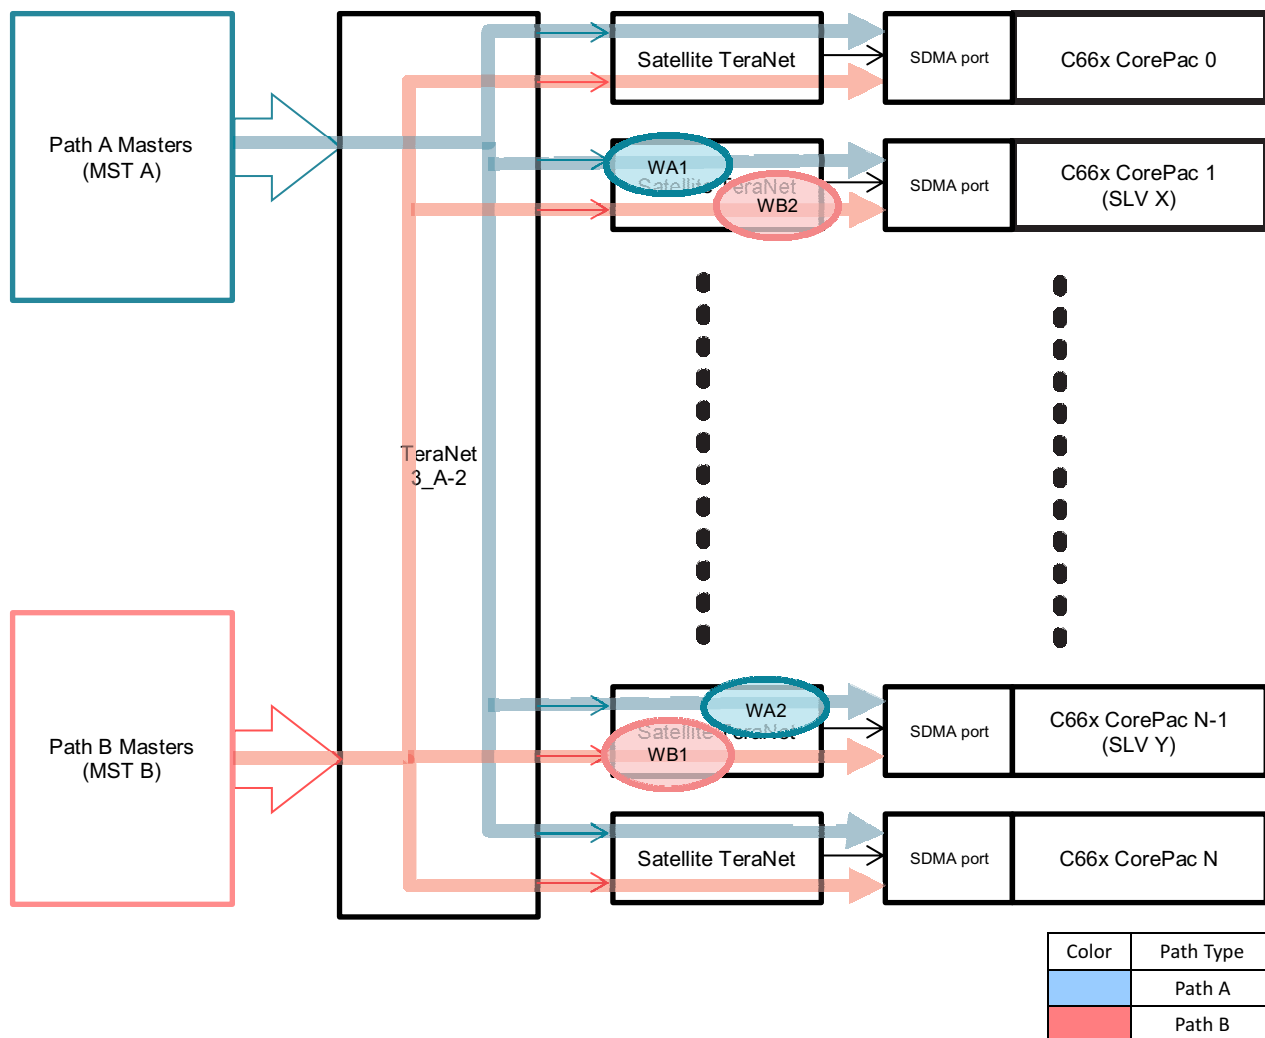
Figure 8. Hang Scenario

Hang Scenario: When a master (MST A) that uses path A and another master (MST B) that uses path B send out two writes each (WA1, WA2 and WB1, WB2) to two C66x CorePac slave end points (SLV X, SLV Y), a hang can occur if the following conditions occur:

- Both masters send one write to each of the two slave end points in opposite order:
 - MST A sends two writes: first write WA1 to SLV X, and second write WA2 to SLV Y
 - MST B sends two writes: first write WB1 to SLV Y, and second write WB2 to SLV X
- Writes from two masters arrive on separate paths at slave endpoint:
 - MST A writes arrive on path A
 - MST B writes arrive on path B
- Both slaves are busy, so they stall the incoming write transactions.
- Both slaves select second writes when they are ready:
 - SLV X selects WB2
 - SLV Y selects WA2

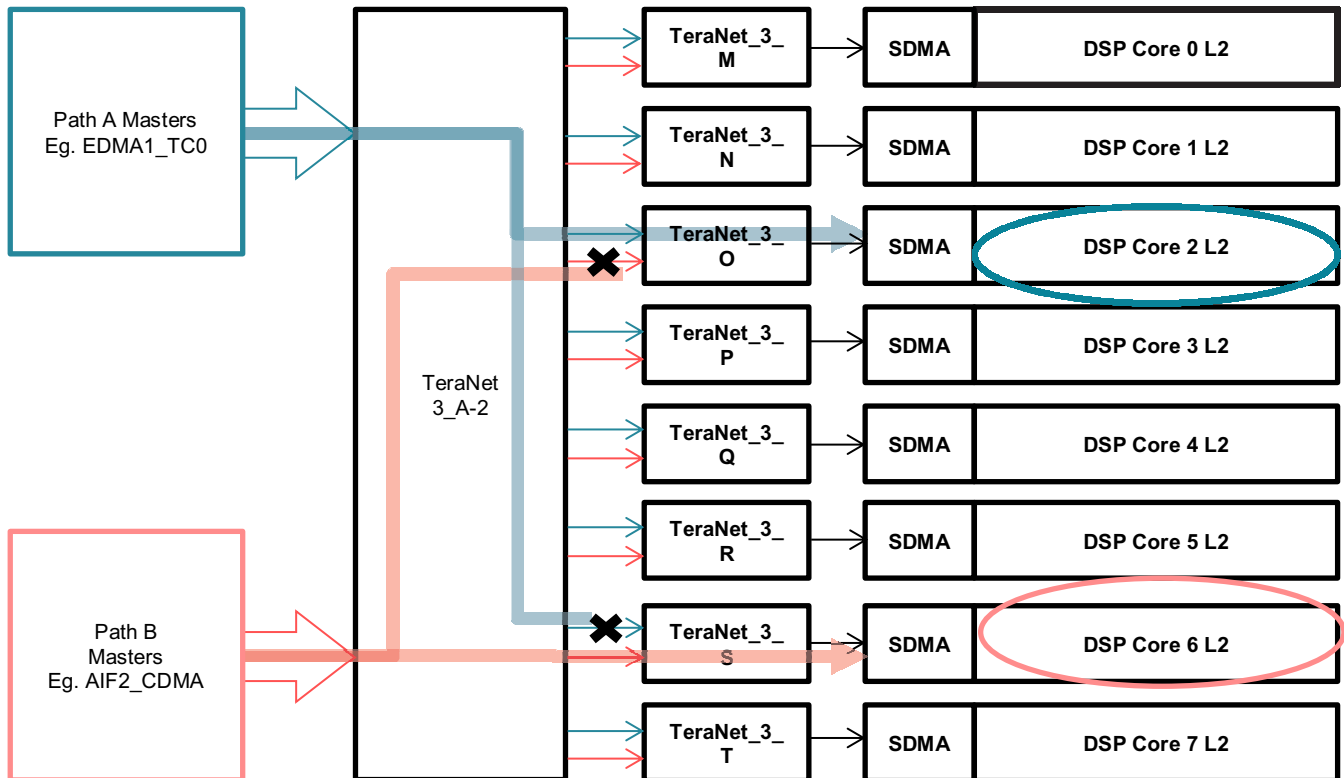
Figure 9. Workaround 1

- The deadlock requires writes arriving on both paths toward the slave, as eliminating writes on one of the paths will eliminate the deadlock.
- Only write to an affected slave by a master that is on the selected path, and stop any writes from any master that uses another path.
- The path to enable can be chosen per affected slave.
- Each affected slave end points should be assigned to either path A master or path B master set.
- All writes to that end point should always be from that pre-assigned set of masters.
- For example, for TCI6638K2K (see [Figure 9](#)) for affected slave end point SDMA ports of core 1,2, 6,7.
 - Assign path A masters to SDMA port of core 1, core2
 - Assign path B masters to SDMA port of core 6, core7
 - Allow writes only from path A masters to core 2, core 1 – SDMA port
 - Allow writes only from path B masters to core 6, core 7 – SDMA port

- Path A masters can write to other affected slaves, which have been assigned path A masters
- Path B masters can write to other affected slaves, which have been assigned path B masters
