FAILURE ANALYSIS REPORT

Part Number: LMZ14202TZ-ADJ/NOPB
WO#: 242261

Date: May 8, 2023
FA Engineer: Roderick Soriano

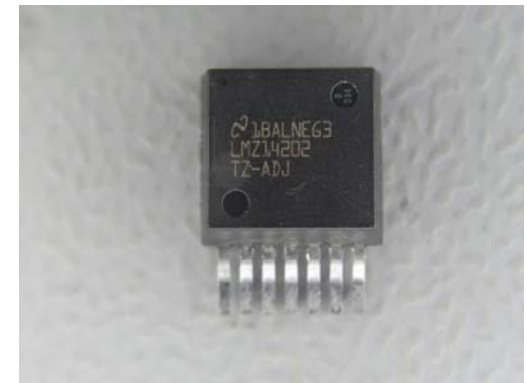
Fail Sample

External visual inspection on good, unused and fail samples upon receipt showed no gross external damaged which can be correlated to customer failure mode.

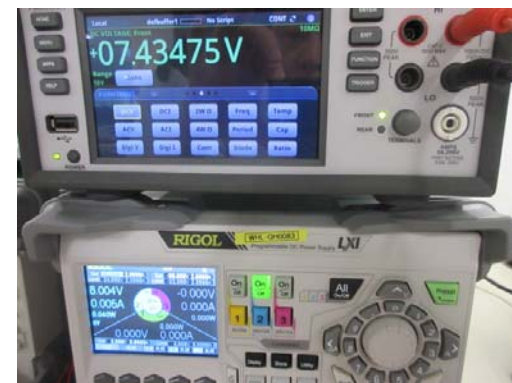
Fail Sample

Test result: High output voltage

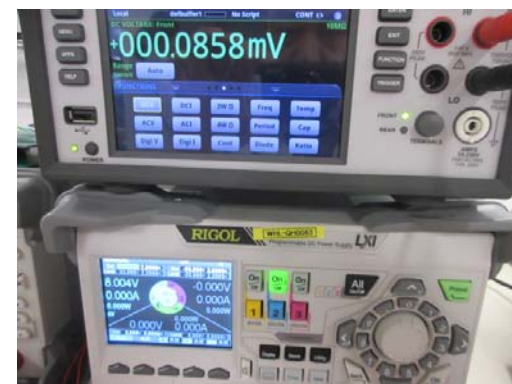
2A current load

Test result: Low output voltage

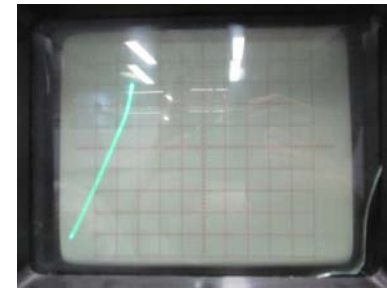
Fail Sample

Verification on fail sample showed resistive current-voltage curve while, the good sample and unused samples showed normal current-voltage curve across all tested pins with respect to ground.

Pin 6 (FB)
vs.
Pin 4 (GND)

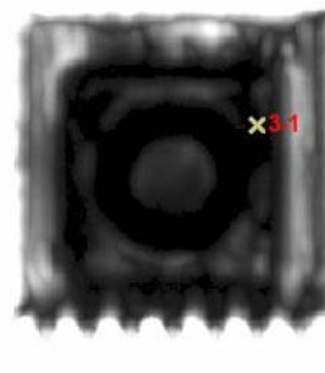
Fail Sample

TSAM Analysis on good, unused and fail samples showed no anomaly on die area. The dark area in the samples are the copper coil which is located above the die surface.

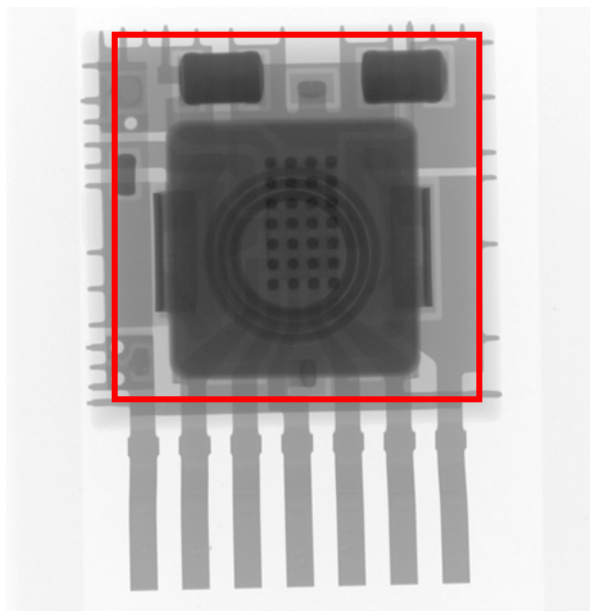
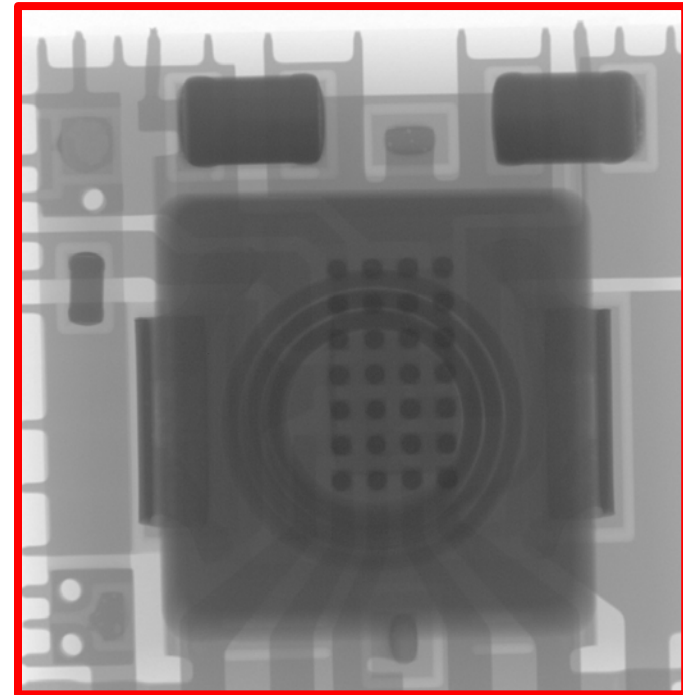
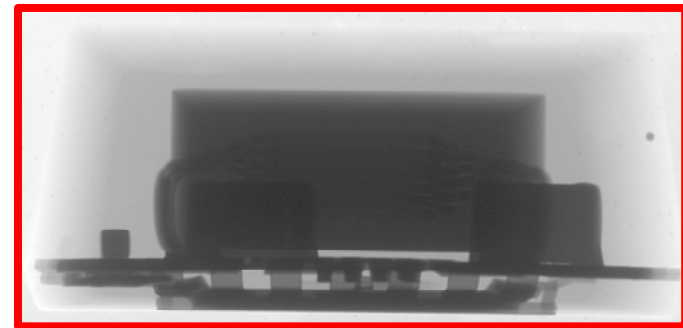
Analysis on fail sample showed normal bump connection with no visible internal anomalies.

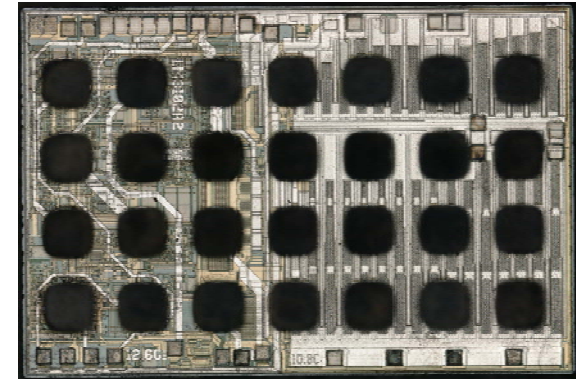
Fail Sample

Decapsulation was performed on good, unused and fail samples to expose the die surface for analysis. Decapsulation on good, unused and fail samples reveals consistent die topography with the same National Semiconductor logo, LM3102A2 and other die markings, verifying that parts were manufactured by Texas Instruments but not traceable to requested part number. National Semiconductor was acquired by Texas Instruments. The good sample and unused sample have die chipping which is due to decapsulation process artifacts.

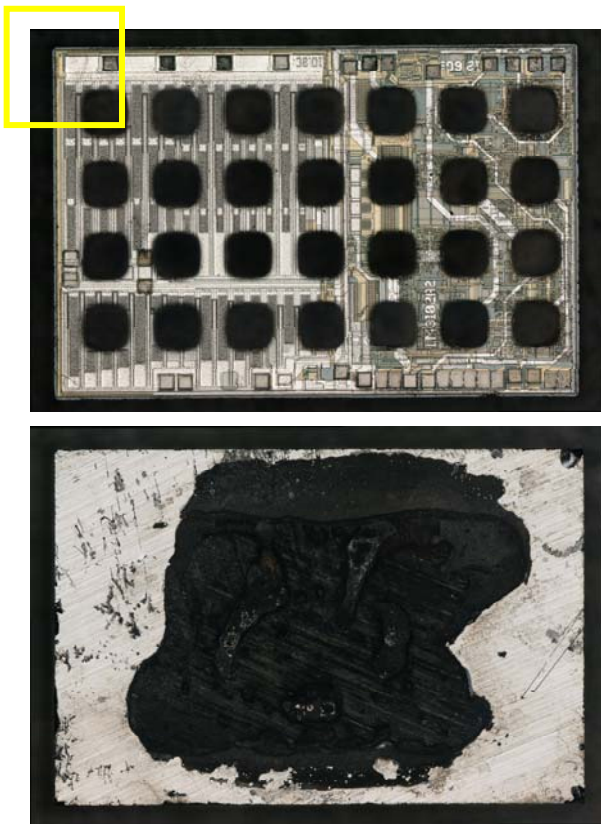
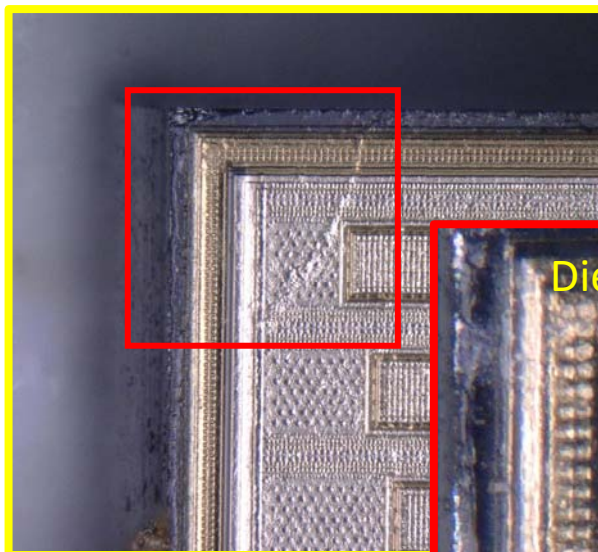
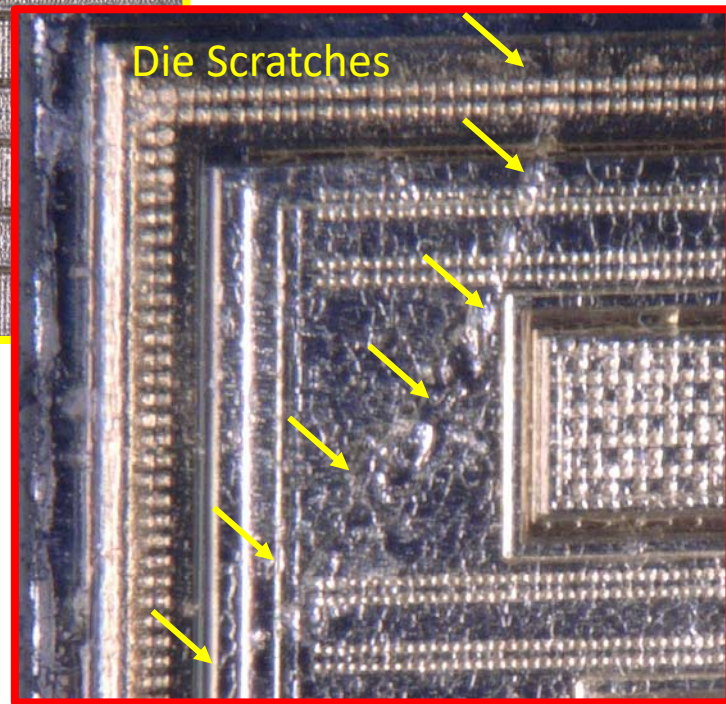
Based on the analysis result, the fail sample failed resistive at pin 5 and pin 6 with respect to ground due to scratches on die surface which probably creates a metal compression and crack propagation inside the die circuitry. The metal compression on die metal lines and propagation of crack inside the die will create a marginal connection between metal lines and gate oxide layer which may result leakage/resistive electrical failure. The scratches in the die surface is a physical damaged which probably induced when that die was still exposed at manufacturer processes from die preparation to die attach process.

Further inspection on the top surface of fail sample showed scratches on die surface.
