# ASK

## AVATR failure parts analysis

# Part 1# Problem description for EOL station

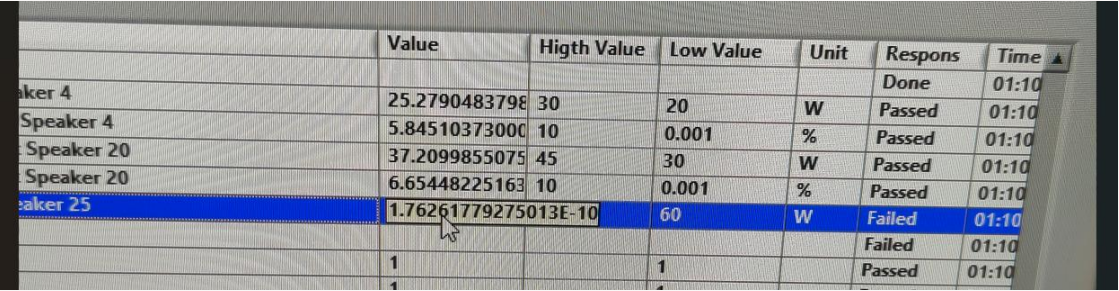
AVATR parts failed in EOL station, the failure item as below, Check spk 25 power output issue.

| | Value | High Value | Low Value | Unit | Respons | Time |
|---|---|---|---|---|---|---|
| Speaker 25 | 1.76261779275013E-10 | 60 | | W | Failed | 01:10 |

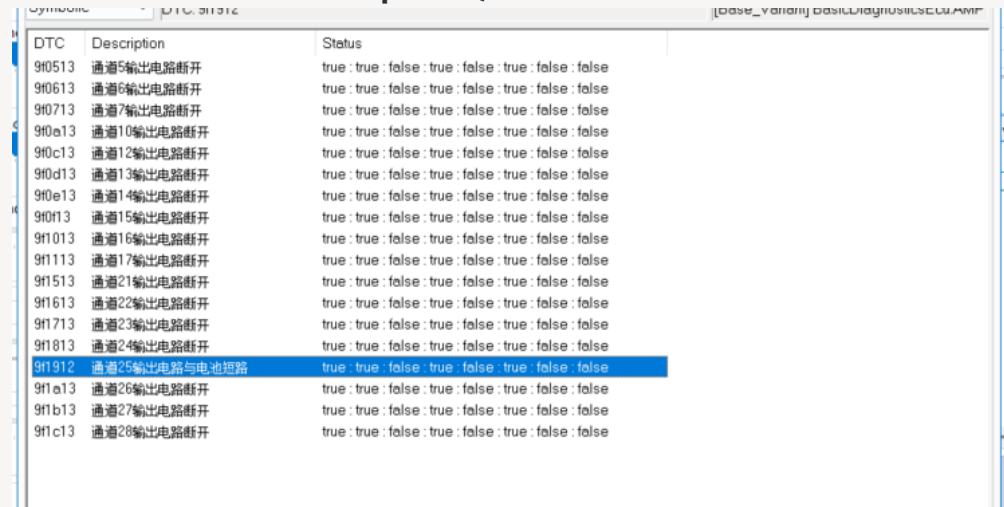
Offline test and confirmed the part failed in self test with same result as EOL test. Read DTC from part, the result is channel 25# output short to battery.

| DTC | Description | Status |
|---|---|---|
| 9H2513 | 通道25输出电路与电池短路 | true : true : false : true : false : true : false : false |

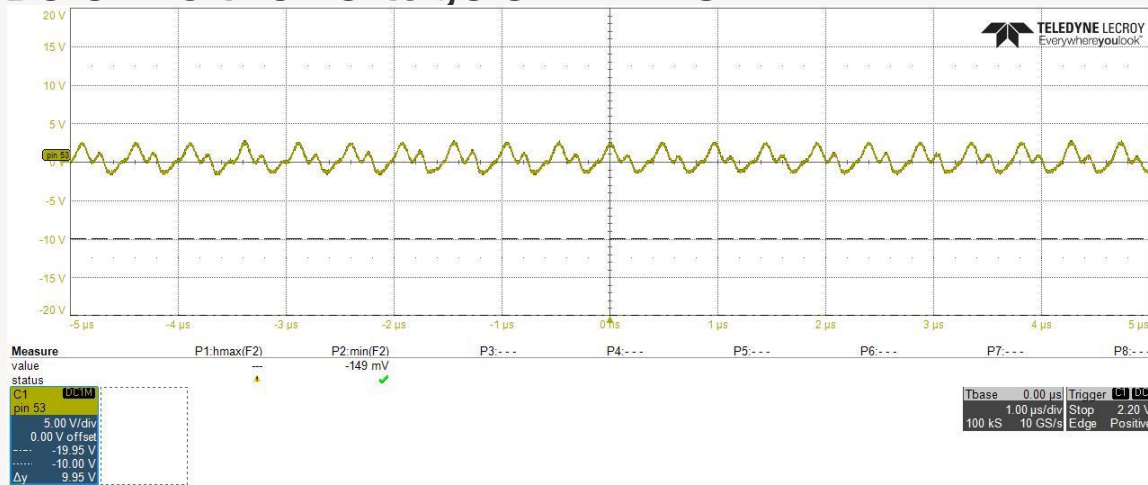
1, Measurement the voltage of power IC, the Spk25 connect PIN40  
Below is the voltage of PIN 40

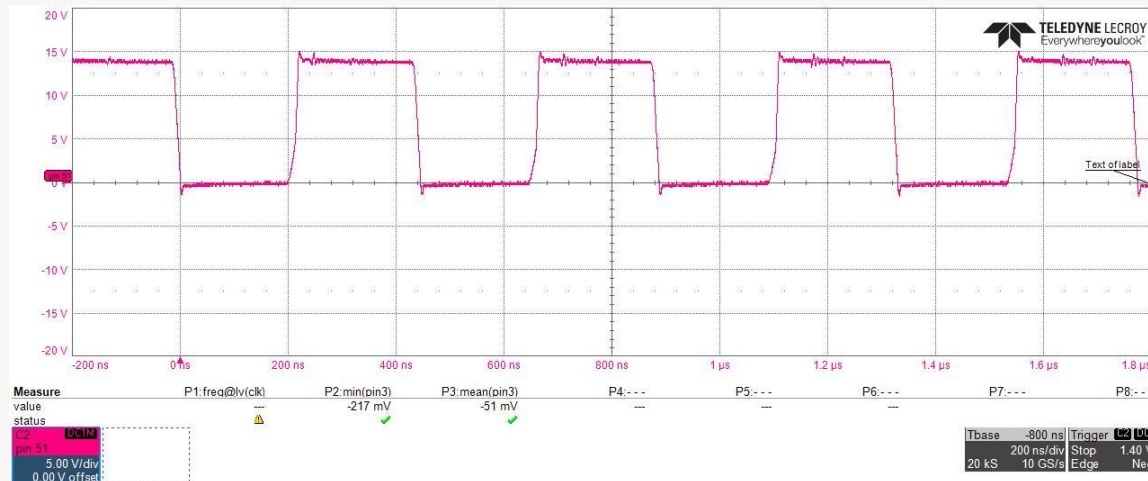
2, Measured the OK part with the same condition below is the voltage of PIN 40

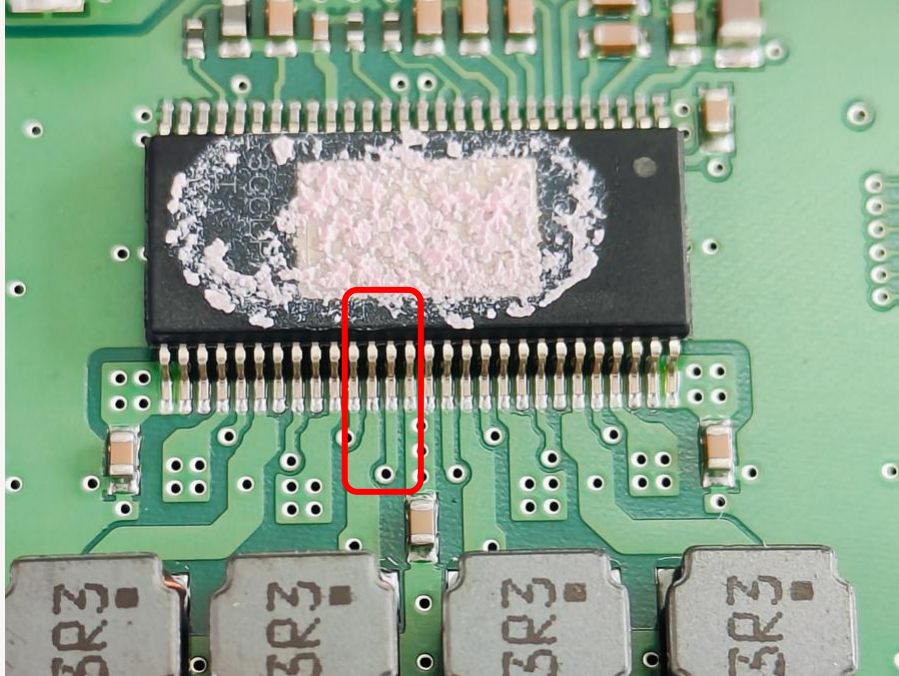
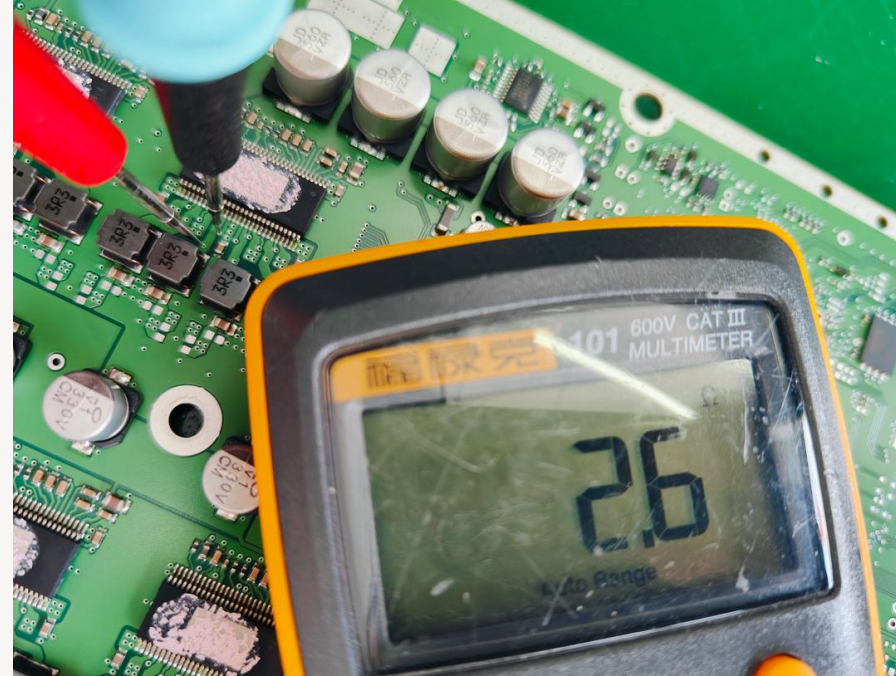
3, Check the soldering of POWER IC, no abnormal found. Measurement the PIN 40 short to PIN41.

Conclusion:  
The PIN 40 short PIN41 caused part have the function failure.

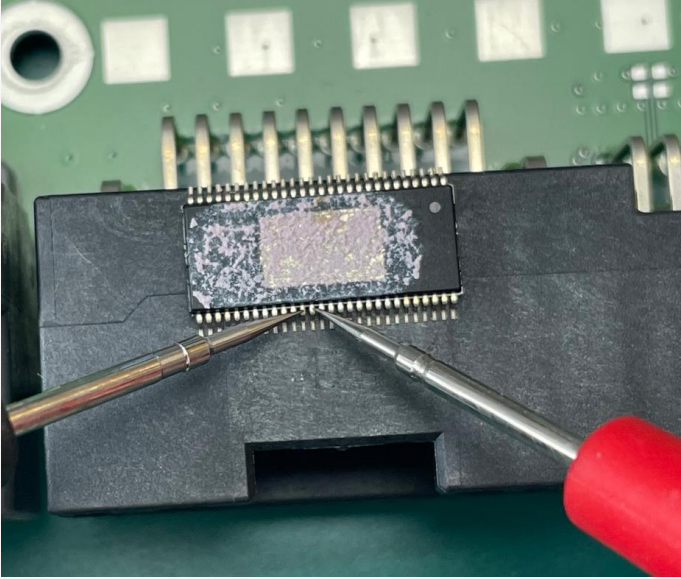
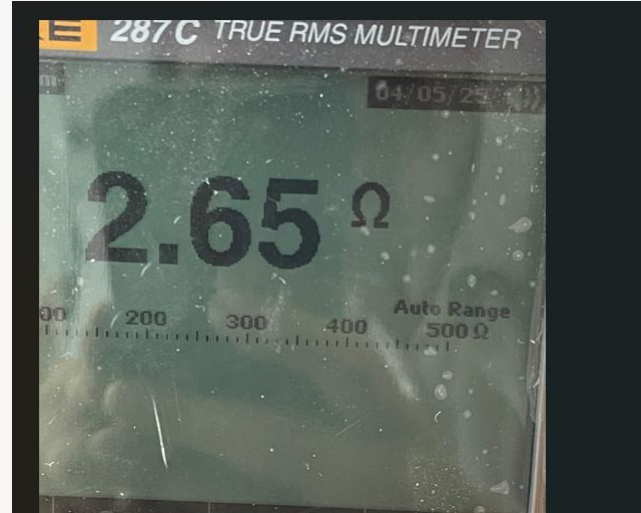
4, dissoldering the power IC and measurement the PIN 40 short to PIN41.
