About LM3485MM Charging Current Low Bad Analysis

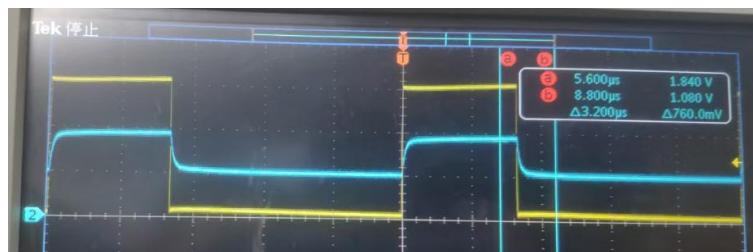
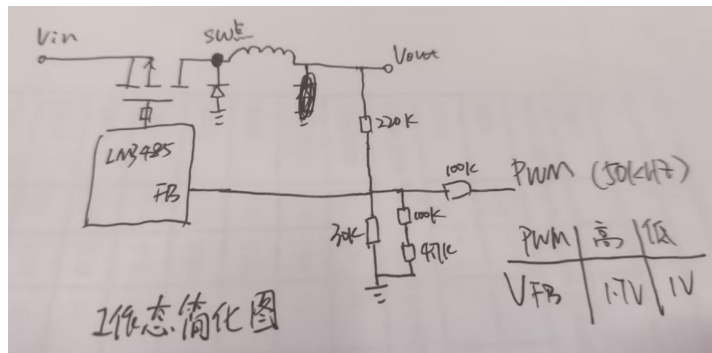
- (1) simplify the circuit diagram and the principle of operation as shown on the right
- (2) the load battery from 13.5V replaced by 11V, the charging current can reach 1.9A
- (3) through the oscilloscope to capture the NG product PWM waveform (yellow) and IC-FB waveform (blue) without delay, the following figure:

Working principle: as above charging simplified schematic, PWM is high (3.3V), FB voltage is about 1.7V greater than 1.242V + 10mV, IC off mos, PWM is low (0V), FB voltage is about 1V lower than 1.242V, IC on MOS. PWM frequency 50kHz. PWM duty cycle through the MCU detects input solar panel voltage and Battery voltage adjustment

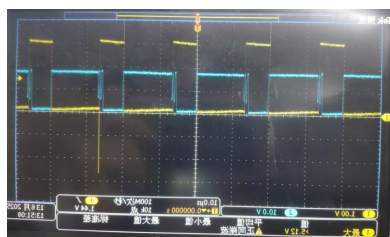
OK

3、capture the PWM (yellow) and SW (blue) switch waveforms found that the normal product almost no delay, NG products have a delay, as follows

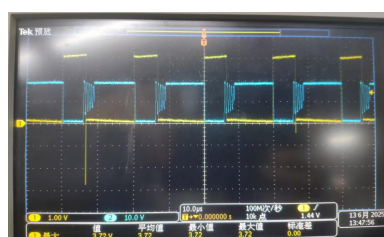
(1) through the analysis of normal products can be synchronous with the PWM signal (or FB signal) to adjust the MOS on/off, NG products can not be synchronous with the PWM signal (or FB signal) to adjust the MOS off

(2) NG products IC-PGATE turn on time in the last shutdown at about 9uS, and can not be further advanced, even if the Vfb is below the threshold
