DM3730, DM3725 Digital Media Processors

Silicon Revisions 1.2, 1.1, 1.0

Silicon Errata

Literature Number: SPRZ319E
August 2010—Revised January 2012

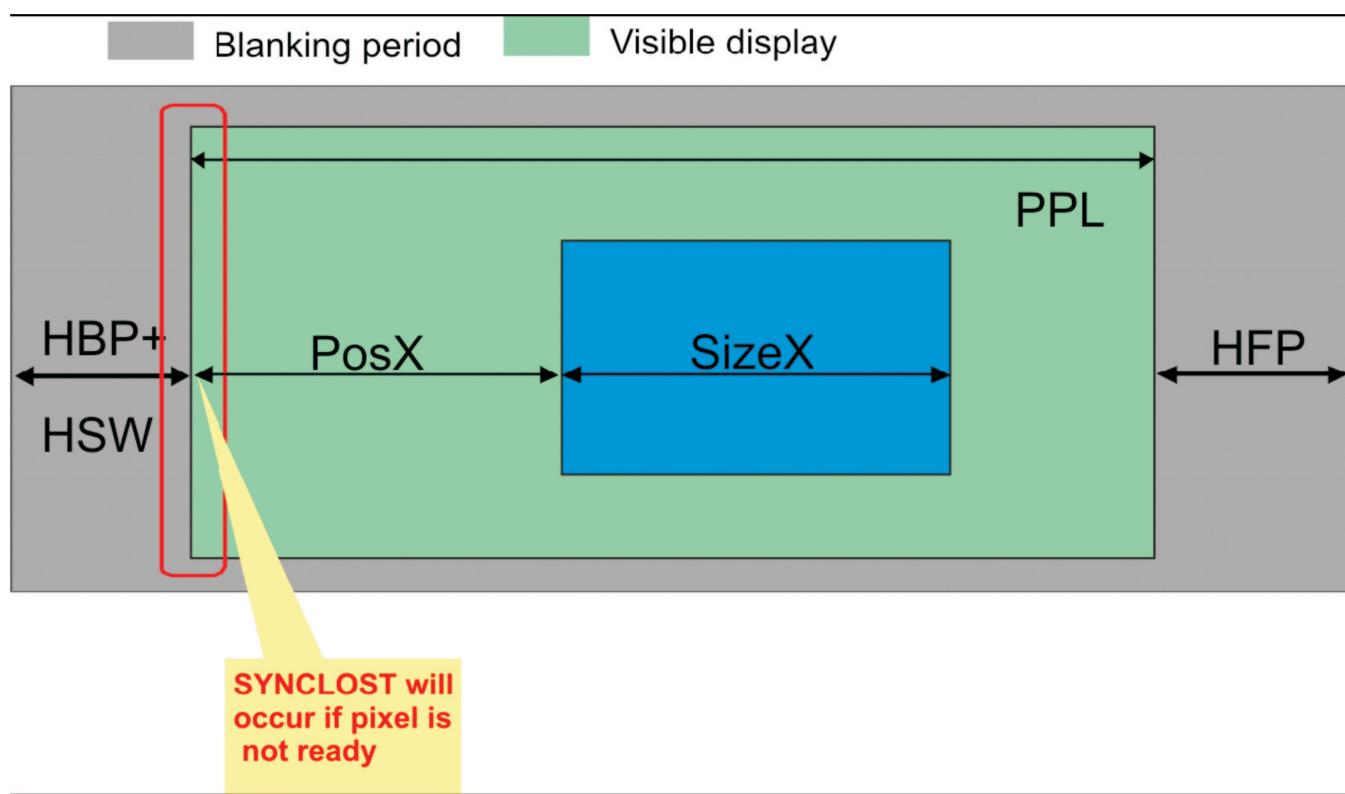
Figure 2. Synclost Interrupt

Synclost interrupts are observed when performing downscaling and shifting resulting windows on the right of the LCD panel. This interrupt occurs because there is not sufficient time to load the necessary lines buffer before performing a downscaling operation. DISPC video pipeline is expected to be ready with the pixels at the end of HSW+HBP period as shown in [Figure 2](#). This limitation is applicable on 3 and 5 taps configuration.

To ensure proper downscaling operation, the following conditions should be met:

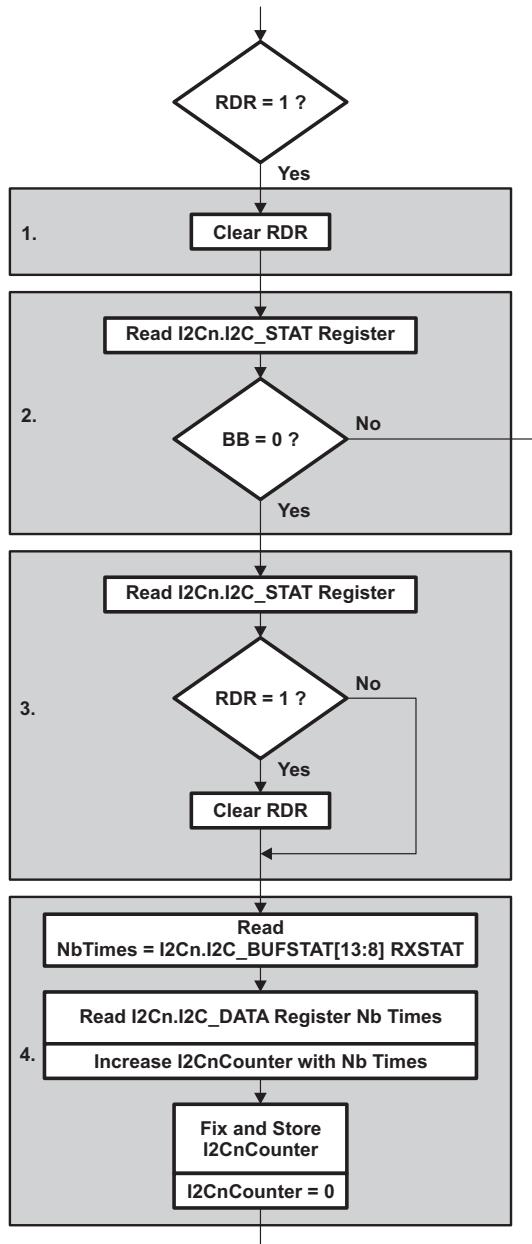
Figure 8. I2C Flowchart

Under certain rare conditions, the I2C_STAT[13].RDR bit may be set as well as the corresponding interrupt fire, even when there is no data in the receive FIFO, or the I2C data transfer is still ongoing. These spurious RDR events must be ignored by the software.

Software must filter out unexpected RDR pulses, using the flowchart illustrated in [Figure 8](#) when receiving an I2C RDR interrupt.

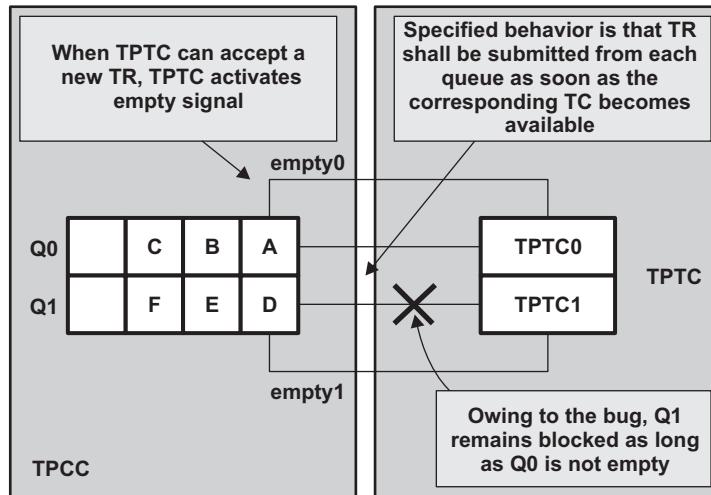
**Figure 9. TR Submission Scheme****Workaround(s)**

The EDMA channel controller (TPCC) has 2 event queues: Q0 and Q1. Each queue can be mapped to one of the two Transfer Controllers (TPTC): TPTC0 or TPTC1. As explained in the *AM/DM37x Multimedia Device Technical Reference Manual* (literature number [SPRUGN4](#)), the events in each event queue will be extracted as soon as the corresponding TPTC is available for a new Transfer Request (TR) to be programmed into the TPTC. However, due to an issue in the IVA2.2 subsystem, the requests queued in Q1 cannot be submitted to their TPTC as long as Q0 is not empty.

Infrequent short transfers (e.g., latency critical synchronized transfers to/from peripheral) must be placed in Q0, and longer transfers (e.g., block copy) in Q1. For example, when a latency critical transfer is placed in EDMA and a longer transfer in QDMA, the following programming model will minimize the impact of this limitation:

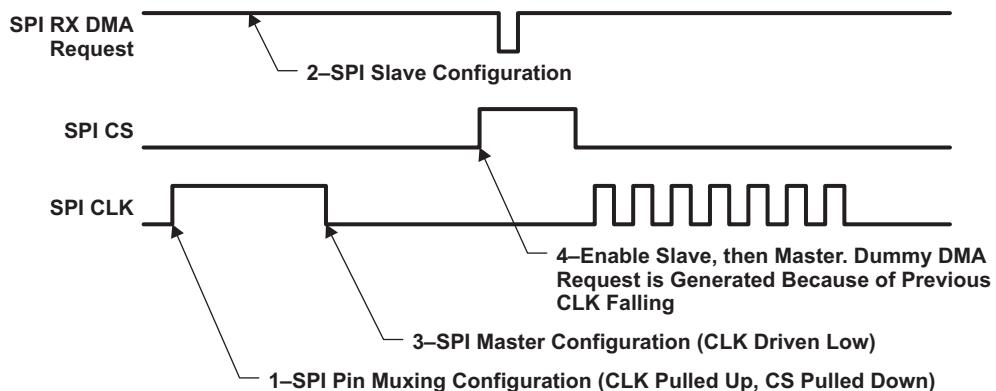
**Figure 10. SPI Dummy DMA RX Generation****Workaround(s)**

A dummy DMA RX request is generated as soon as the SPI is configured in *slave* mode and a SPI clock edge is detected. The dummy DMA RX request is generated during module configuration, when the module is not performing an SPI transfer. The dummy DMA RX request occurs as soon as the SPI interface signal sensitivity is changed compared to the default value.

The dummy DMA RX request is generated because the mechanism to avoid dummy data capture on a CS glitch is done regardless of channel activation.

Avoid conditions where the SPI is in *slave* mode and the SPI clock toggles (see examples below).
