# **Sitara™ AM335x ARM® Cortex™-A8 Microprocessors (MPUs) Silicon Revisions 2.1, 2.0, 1.0**

## **Silicon Errata**

Literature Number: SPRZ360F  
October 2011–Revised November 2013

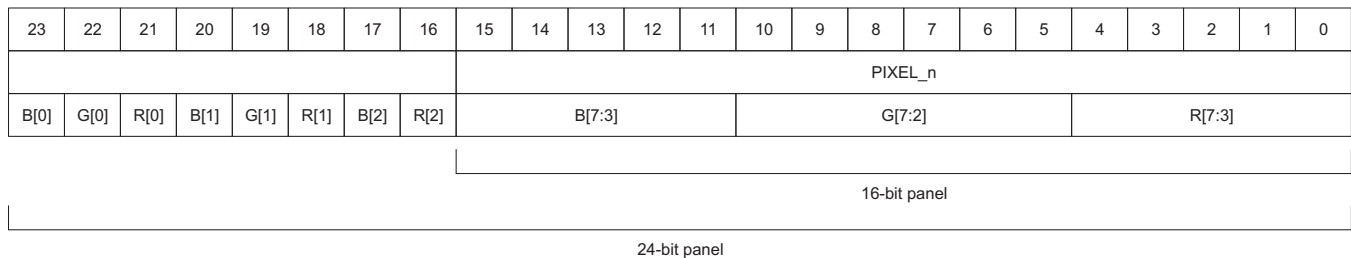
**Figure 2. RGB888 Mode LCD Controller Output Pin Mapping (LCD\_DATA[23:0])**

The blue and red color assignments to the LCD data pins are reversed when operating in RGB888 (24bpp) mode compared to RGB565 (16bpp) mode. In order to correctly display RGB888 data from the SGX, or any source formatted as RGB in memory, it is necessary to connect the LCD panel as shown in [Figure 2](#). Using the LCD Controller with this connection scheme limits the use of RGB565 mode. Any data generated for the RGB565 mode requires the red and blue color data values be swapped in order to display the correct color.

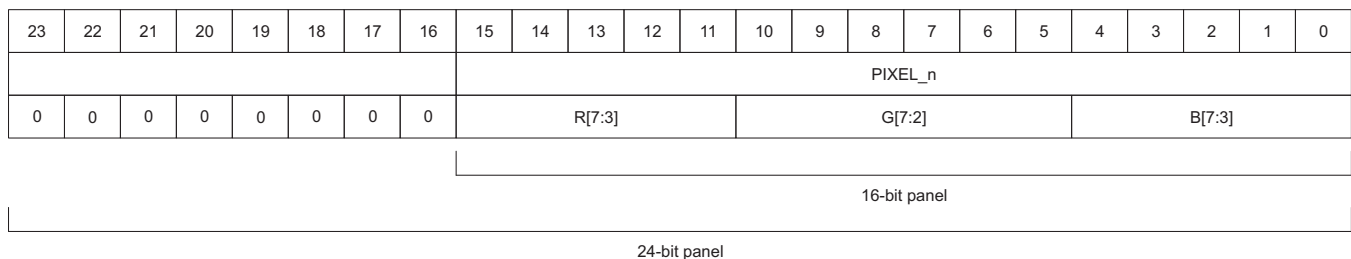
**Figure 3. RGB565 Mode LCD Controller Output Pin Mapping (LCD\_DATA[23:0])**

When operating the LCD Controller in RGB565 mode the LCD panel should be connected as shown in [Figure 3](#). Using the LCD Controller with this connection scheme limits the use of RGB888 mode. Any data generated for the RGB888 mode requires the red and blue color data values be swapped in order to display the correct color.

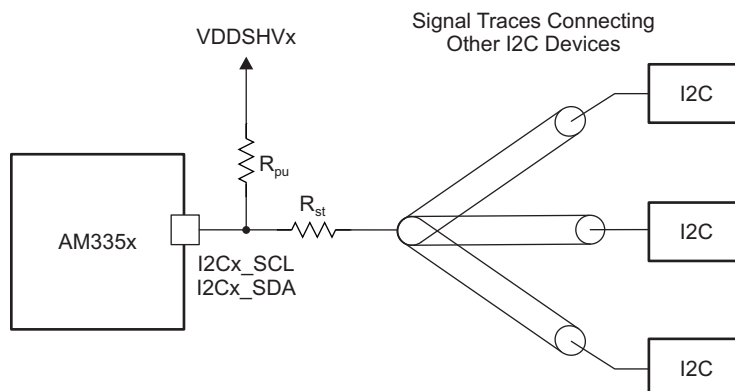
**Figure 4. Placement of Series Termination Resistor and Pullup Resistor**

The I2Cx\_SDA and I2Cx\_SCL outputs are implemented with push-pull 3-state output buffers rather than open-drain output buffers as required by I2C. While it is possible for the push-pull 3-state output buffers to behave as open-drain outputs, an internal timing skew issue causes the outputs to drive a logic-high for a duration of (0–5 ns) before the outputs are disabled. The unexpected high-level pulse will only occur when the SCL or SDA outputs transition from a driven low state to a high-impedance state and there is sufficient internal timing skew on the respective I2C output.

This short high-level pulse injects energy in the I2C signals traces, which causes the I2C signals to sustain a period of ringing as a result of multiple transmission line reflections. This ringing should not cause an issue on the SDA signal because it only occurs at times when SDA is expected to be changing logic levels and the ringing will have time to damp before data is latched by the receiving device. The ringing may have enough amplitude to cross the SCL input buffer switching threshold several times during the first few nanoseconds of this ringing period, which may cause clock glitches. This ringing should not cause a problem if the amplitude is damped within the first 50 ns because I2C devices are required to filter their SCL inputs to remove clock glitches. Therefore, it is important to design the PCB signal traces to limit the duration of the ringing to less than 50 ns. One possible solution is to insert series termination resistors near the AM335x SCL and SDA terminals to attenuate transmission line reflections.

This issue may also cause the SDA output to be in contention with the slave SDA output for the duration of the unexpected high-level pulse when the slave begins its ACK cycle. This occurs because the slave may already be driving SDA low before the unexpected high-level pulse occurs. The glitch that occurs on SDA as a result of this short period of contention does not cause any I2C protocol issue but the peak current applies unwanted stress to both I2C devices and potentially increases power supply noise. Therefore, a series termination resistor located near the respective AM335x SDA terminal is required to limit the current during the short period of contention.

A similar contention problem can occur on SCL when connected to I2C slave devices that support clock stretching. This occurs because the slave is driving SCL low before the unexpected high-level pulse occurs. The glitch that occurs on SCL as a result of this short period of contention does not cause any I2C protocol issue because I2C devices are required to apply a glitch filter to their SCL inputs. However, the peak current applies unwanted stress to both I2C devices and potentially increases power supply noise. Therefore, a series termination resistor located near the respective AM335x SCL terminal is required to limit the current during the short period of contention.

Insert series termination resistors on the SCL and SDA signals and locate them near the AM335x SCL and SDA terminals. The SCL and SDA pullup resistors should also be located near the AM335x SCL and SDA terminals. The placement of the series termination resistor and pullup resistor should be connected as shown in [Figure 4](#).

Table 6 provides series termination and pullup resistor value recommendations. The I2C signal level and respective  $VDDSHVx$  power supply voltage is shown in the first column. Two resistor value combination options are provided for each voltage. One option supports a maximum high-level input current of 200  $\mu A$  to all attached I2C devices, while the other option supports a maximum high-level input current of 100  $\mu A$  to all attached I2C devices.

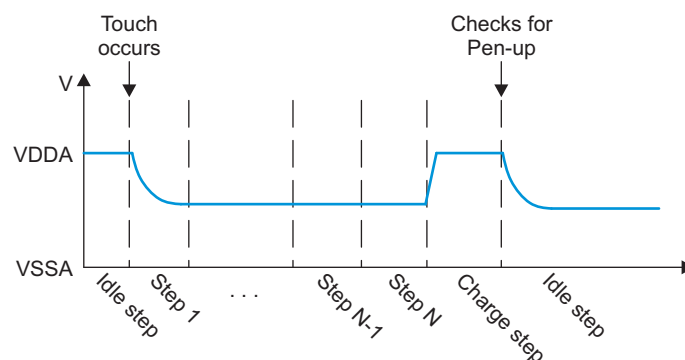
**Figure 5. TSC Generates False Pen-up Interrupt**

**Details** The touchscreen controller (TSC) determines the pen state (up or down) by checking the respective analog input (AIN0 for 4-wire or AIN4 for 5-wire) voltage level immediately after the Charge step. This does not provide enough time for the analog input voltage to return to the normal Pen-down voltage before testing the pen state. This will cause the TSC to generate a false Pen-up interrupt if the Charge step is enabled with the strong pull-up turned on when using hardware synchronized steps. [Figure 5](#) illustrates the effect on the analog voltage when constant pen pressure is applied to the touchscreen and held through the Charge step.
