## Stellaris® LM3S9B96 RevB1 Errata

This document contains known errata at the time of publication for the Stellaris® LM3S9B96 microcontroller. The table below summarizes the errata and lists the affected revisions. See the data sheet for more details.

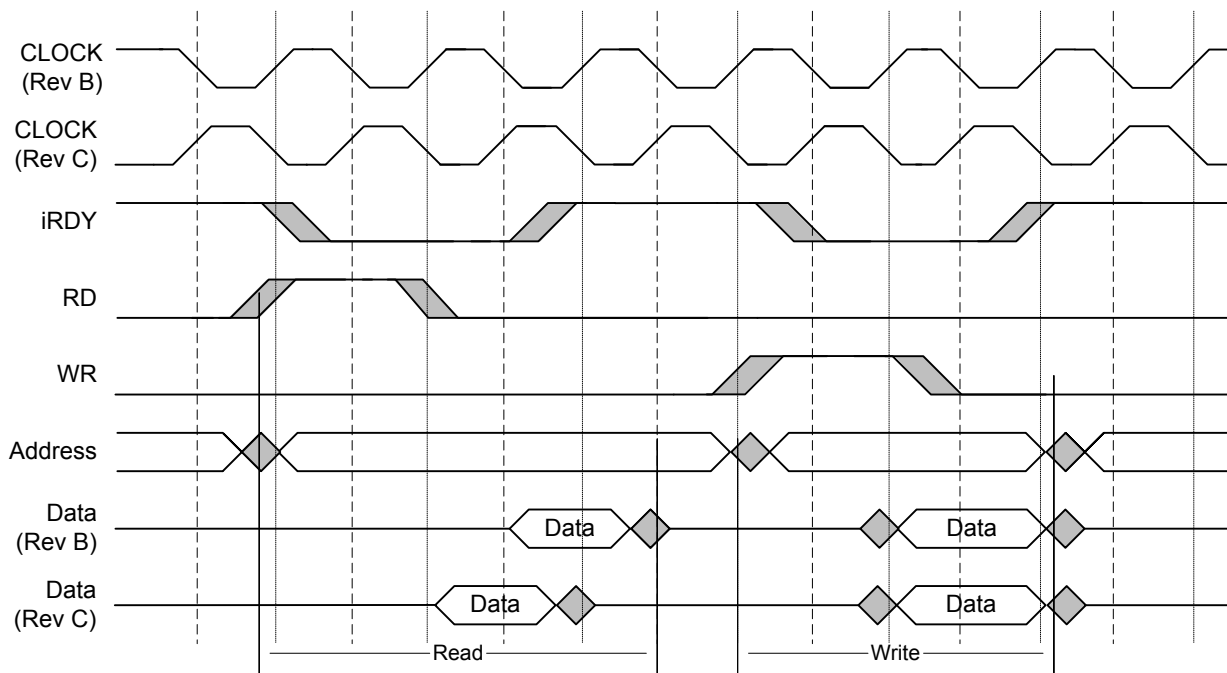
**Figure 1. Timing Differences Between Rev B and Rev C Devices**

The clock signal that is output on the EPIO31 signal in General-Purpose mode is inverted. Figure 1 on page 13 shows the timing differences between Rev B parts and Rev C parts.

Use the opposite edge for timing when designing with this interface. During read cycles, ensure that the data meets set up and hold times for the appropriate edge as shown in the diagram above.

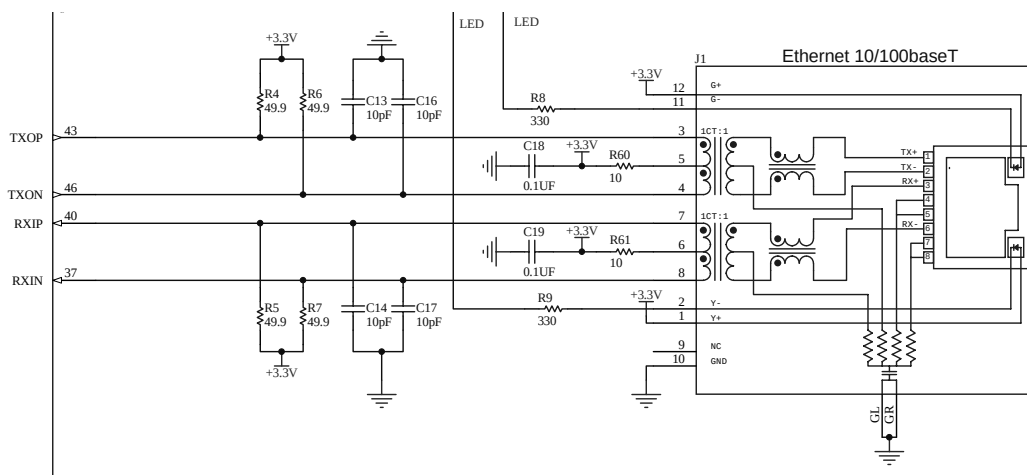
**Figure 2. Recommended Center-Tap Connections**

The microcontroller experiences some packet loss with Ethernet cables longer than 50 meters in normal operating conditions.

1. Add 10  $\Omega$  resistor to the center-tap of the transformer as shown in the figure. These resistors should be replaced by a direct connection for silicon that has this item fixed.
2. Continue using the recommended circuit, but limit cable lengths to 50 meters.

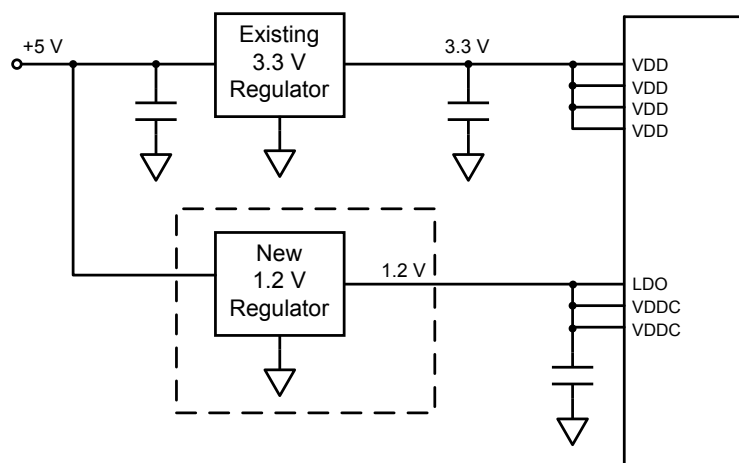
**Figure 7. Configuration of External Regulator**

Incorrect power sequencing during power up can disrupt operation and potentially cause device failure.

$V_{DDC}$  must be applied approximately 50  $\mu$ s before  $V_{DD}$ . Normally  $V_{DDC}$  is controlled by the part's internal LDO voltage regulator. The workaround requires the addition of an external regulator (see Figure 7) to ensure that  $V_{DDC}$  sequencing requirements are met (see Figure 8). A recommended regulator is the TI TPS73101DBVR.

This fix mitigates the on-chip power issue, but does not solve it completely. During development, the Flash memory should also be reprogrammed (using LMFlash or another programming tool) at least once a week.
