Laboratory Analysis Report

Report Number: 1000-33725

Manufacturer Part Number: TPS3823-50DBVR

Part Description: PROCESSOR SUPERVISOR 4.55V 1 ACTIVE LOW/PUSH-PULL AUTOMOTIVE 5-PIN SOT-23 T/R

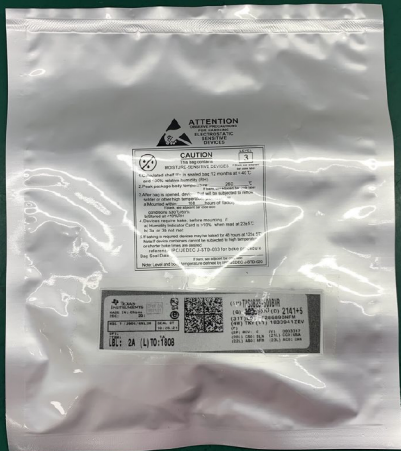
Figure 1. RECEIVED

Total 1000pcs was received in tape format.

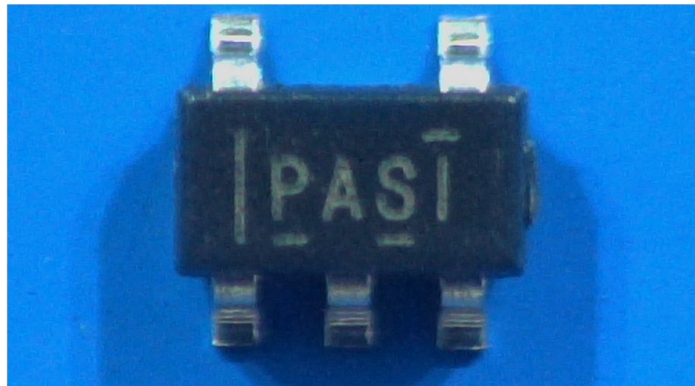
Figure 4. TOP

1.2.1	Condition Observed	10	10	0		No anomalies were found. Devices passed visual inspection.
1.3.0	Package Inspection - 1 Device (SAE AS6081 and MIL-STD-883, Method 2009.9) (Non-destructive)

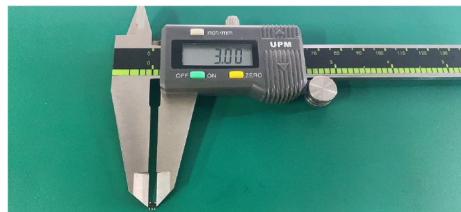
Figure 10. LENGTH

Length = 3.00mm (2.75mm min - 3.05mm max) Pass

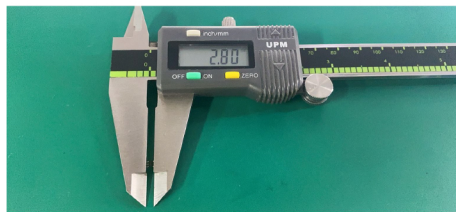
Figure 11. WIDTH

Width = 2.80 mm (2.6mm min -3.0 mm max) - Pass

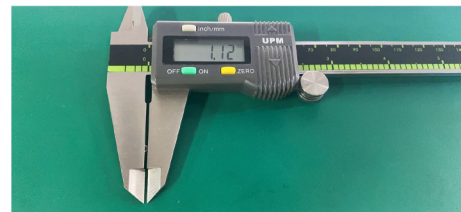
Figure 12. THICKNESS

Thickness = 1.12mm (0.9mm min -1.45 mm max) - Pass

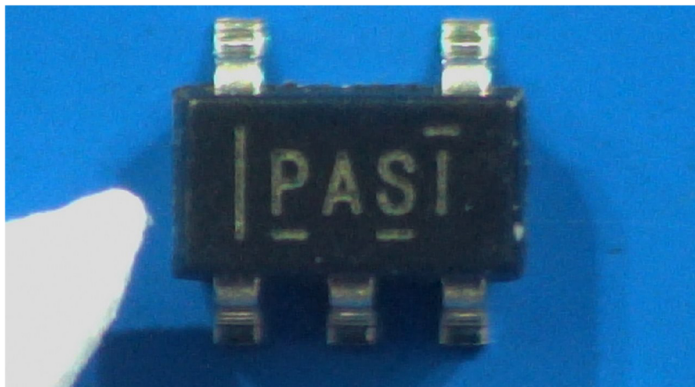
Figure 14. HCT

1.5.0	Re-Surfacing Testing - Dynasolve 750 - 1 Device					
1.5.1	Heat Solvent (Destructive) Dynasolve 750	1	1	0		Heated Solvent Testing was performed on 1 device using Dynosolve 750 solution. Material was soften during this process however no evidence of a secondary coating was observed. Device passed Heated Solvent testing.

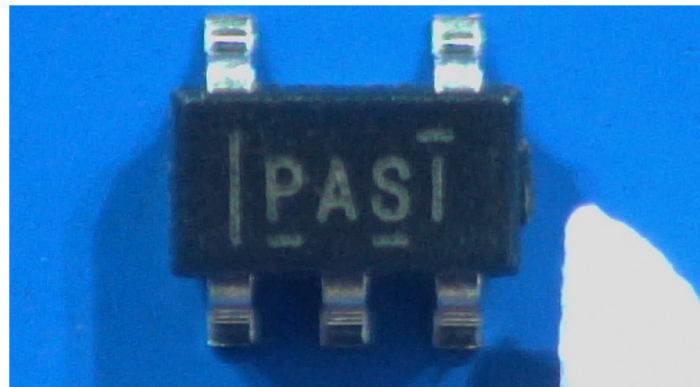
Figure 15. PERMANENCY

1.4.1	Permanency (Non-destructive) (SAE AS6081 4.2.6.4.3A)	1	1	0		Marking permanency test was performed on 1 device. No marking was removed during this process. The device passed permanency testing.

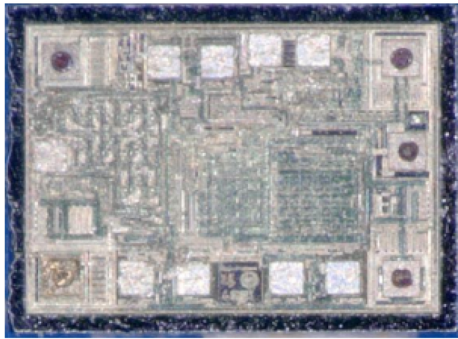
Figure 16. DIE

Internal inspection was performed on 1 device. Device revealed Texas Instruments logo with 1997 copyright. Die marking 94741WM50B was also found.

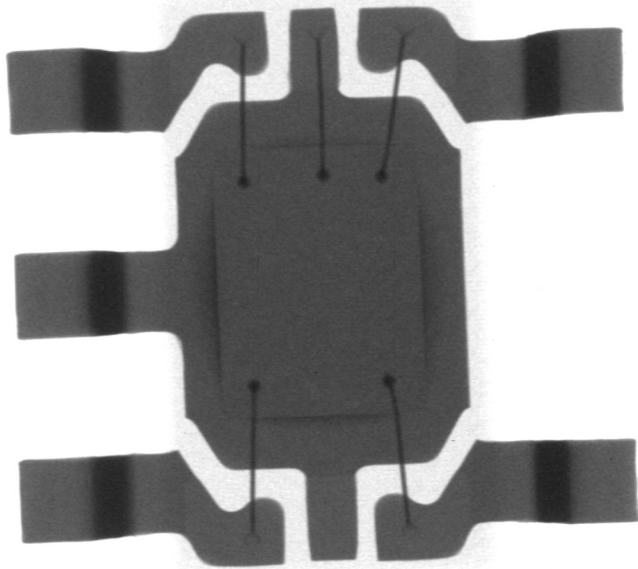
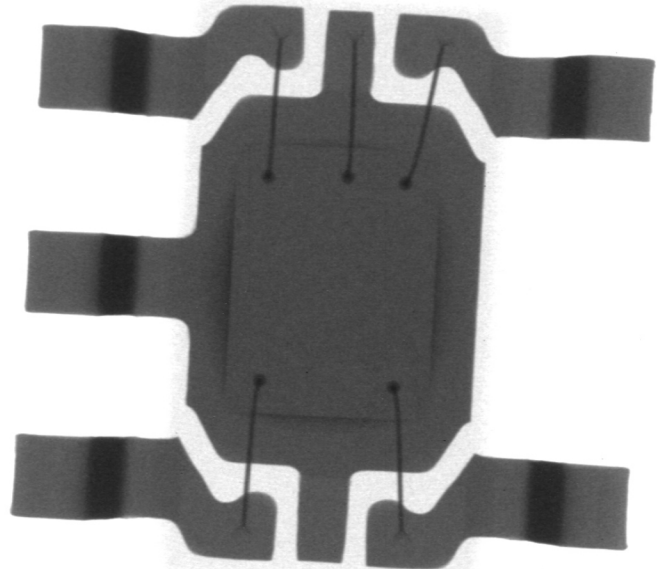
10 samples were X-ray. Die construction and size are all the same. No anomalies were found.

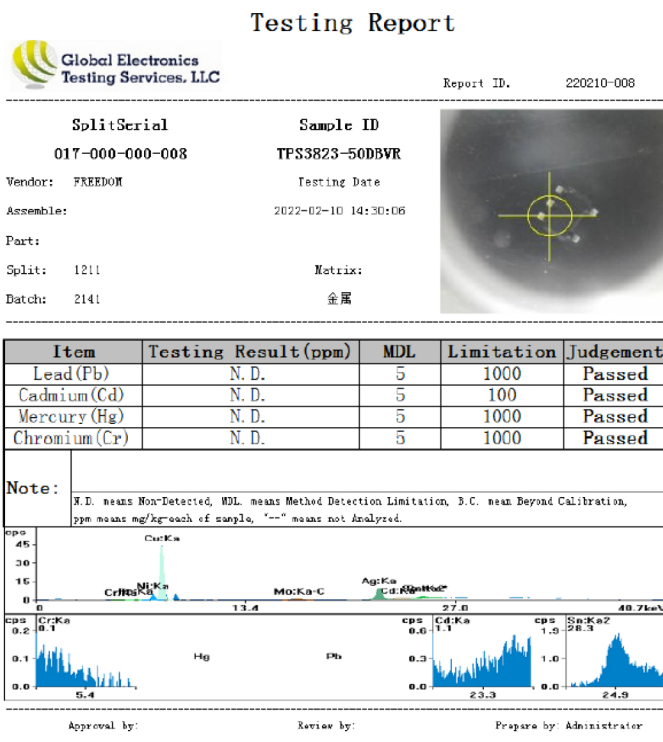
Figure 29. XRF 1

XRF were performed on 1 sample. No restricted elements were detected. Devices meet EU RoHS Directive 2011/65/EU Annex. Devices confirmed to be RoHS compliant.

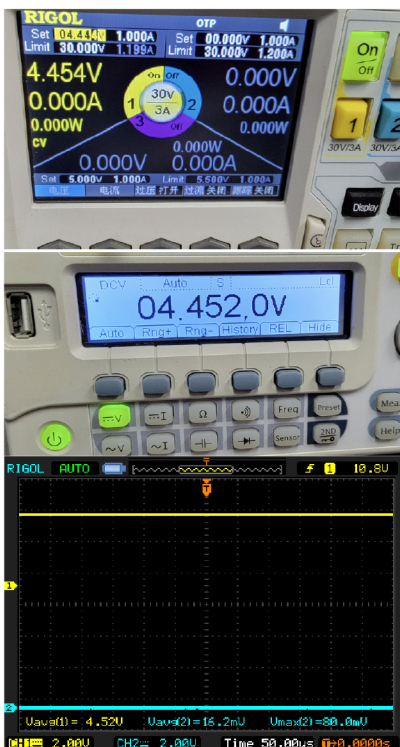
Figure 34. RESET_VOUT = 0V (LOW LOGIC) AT VCC = 4.452V

Power supply
V_{cc} = 4.454(V)

Voltmeter
V_{CC} = 4.452(v) observed

Oscilloscope
Ch1=V_{cc}
Ch2=/Reset_vout = 0v

VIT- = 4.452v observed
VIT- range = 4.49v min, 4.55v typ, 4.64v max
Failed!

Results Summary TPS3823-50DBVR: Processor Supervisor 4.55V 1 Active Low/Push-Pull Automotive 5-Pin SOT-23 T/R Tested 10 samples,failed 10 samples for VIT- <4.49v min (range = 4.49v min,4.55v typ,4.64v max)
--

VIT- Average = 4.389v observed
VIT- range = 4.49v min, 4.55v typ, 4.64v max
10 samples failed!
