TCI6636K2H

Multicore DSP+ARM KeyStone II SOC

Silicon Revisions 1.0, 1.1, 2.0, 3.0, 3.1

Silicon Errata

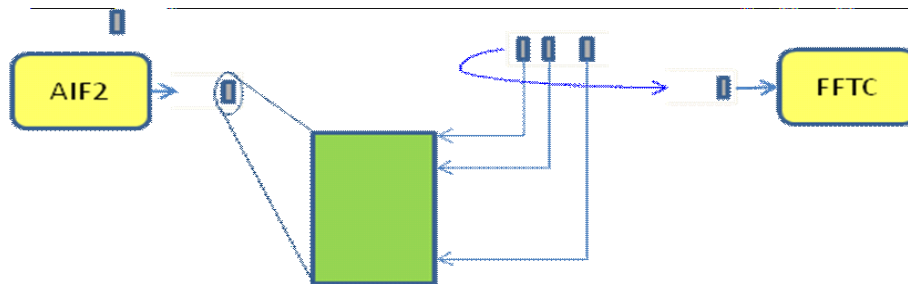
Figure 11. Symbol Processing on Ingress

- On ingress, the symbol processing is not triggered upon receiving the jumbo packet, instead it is triggered based on AT event. As AT event doesn't have association with the availability in memory, application needs to program AT event with enough offset to the actual symbol timing to guarantee the data availability in memory.
- On egress, no need to produce the entire jumbo packet before pushing the packet to AIF2, symbols can be produced on symbol basis with enough margin before AIF2 needs it. The margin is related to the pre-fetch buffer size set in AIF2.

[Figure 11](#) shows detailed description on Ingress:

Pre-configure a set of descriptors that point to the correct offset in jumbo packet for each symbol, store the descriptors in the FFTC Tx FDQ or an array. AT event trigger the EDMA to pop and push the descriptors from FFTC Tx FDQ to FFTC Tx Q. EDMA needs to pop the descriptor from the Tx FDQ and push to the FFTC Tx Q. If the AIF2 output packet PS words are needed, then it will need to be copied by EDMA before pushing the descriptor to the FFTC Tx Q. If using AT event to trigger EDMA, after pushing the descriptor, EDMA needs to clear the CP_INTC to prepare the subsequent AT event trigger. As there is no real need for the AIF2 output queue itself, AIF2 Rx Q can be set to be the same queue as the Rx FD, Therefore no need to recycle the AIF2 output descriptor.

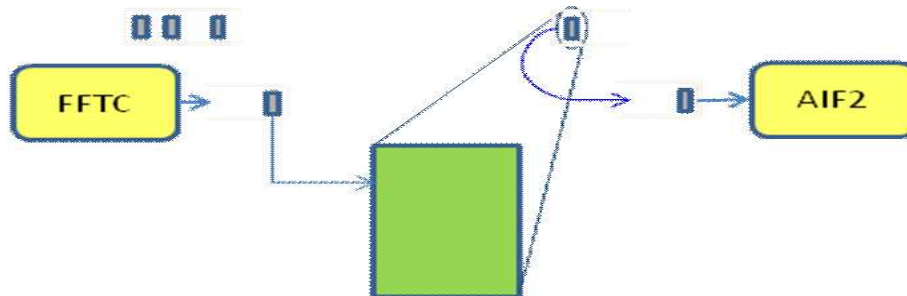
Figure 12. Symbol Processing on Egress

Detailed description on Egress is shown in [Figure 12](#).

Assuming FFTC generates the packet, FFTC Rx FDQ needs to be prepared such that the descriptors point to the right position of the AIF2 jumbo packet for each symbol. Once every jumbo packet period, the jumbo packet descriptor can be pushed to AIF2 Tx queue. This can potentially be done by CPU as it is likely that it could be aligned with LTE DL symbol processing. As there is no real need for the FFT output descriptor itself, FFTC Rx Q can be set to be the same queue as the Rx FDQ, Therefore no need to recycle the FFTC output descriptor.
