DM3730, DM3725 Digital Media Processors

Silicon Revisions 1.2, 1.1, 1.0

Silicon Errata

Literature Number: SPRZ319E
August 2010—Revised January 2012

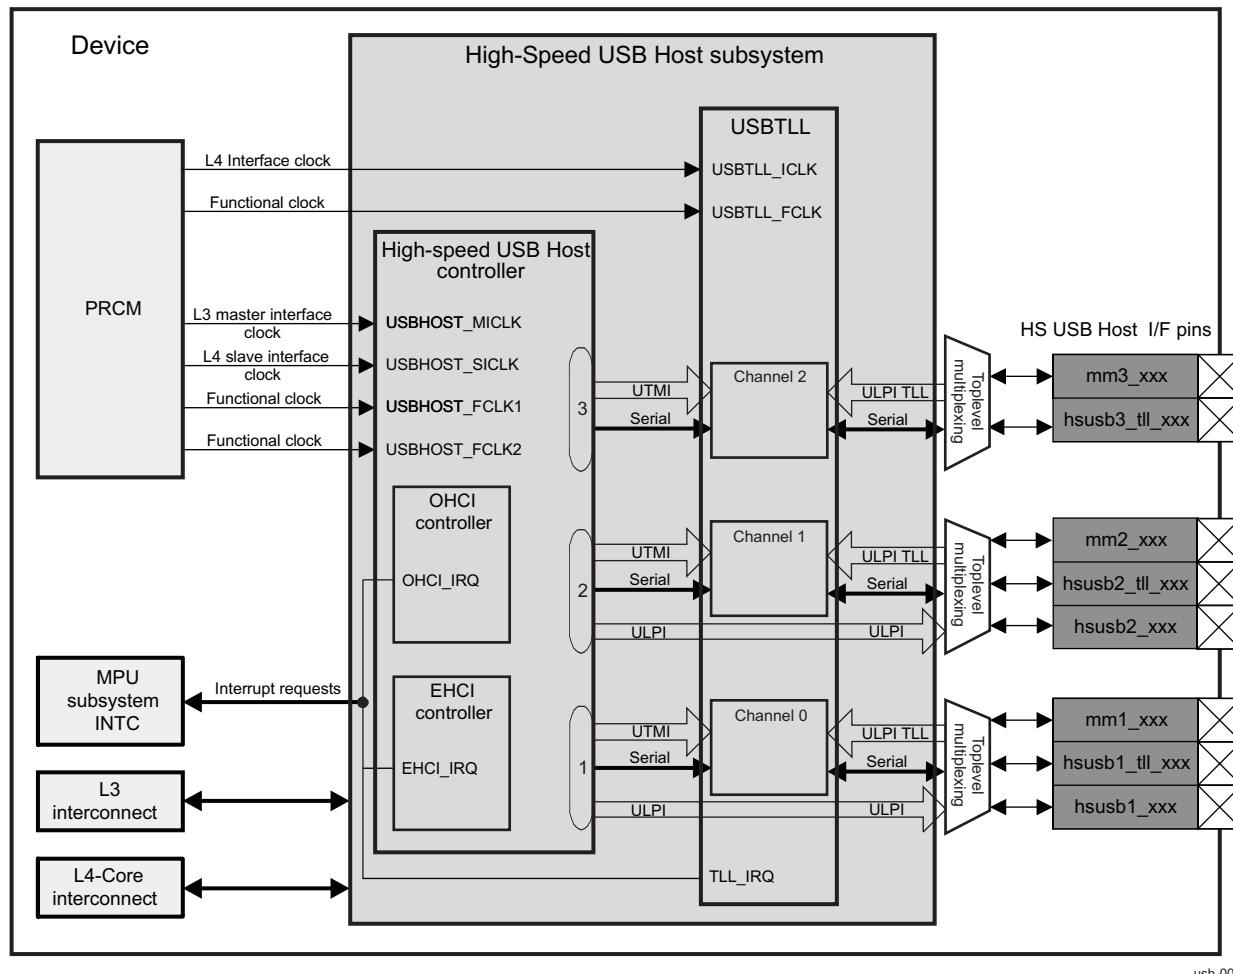
Figure 5. High-Speed USB Host Subsystem Highlight

Please note the following functional limitations when using the high-speed USB host subsystem:

- On silicon revision 1.0 only, if one port is configured in the ULPI mode, then all other ports must use the same configuration. Therefore, the ports must be configured high-speed mode or full-speed/low-speed mode. For more information, see [Advisory 1.55](#).
- USB Port 3 cannot operate in ULPI mode; it can only operate in serial or ULPI TLL mode. Furthermore, USB Port 3 is not available in the CUS package.

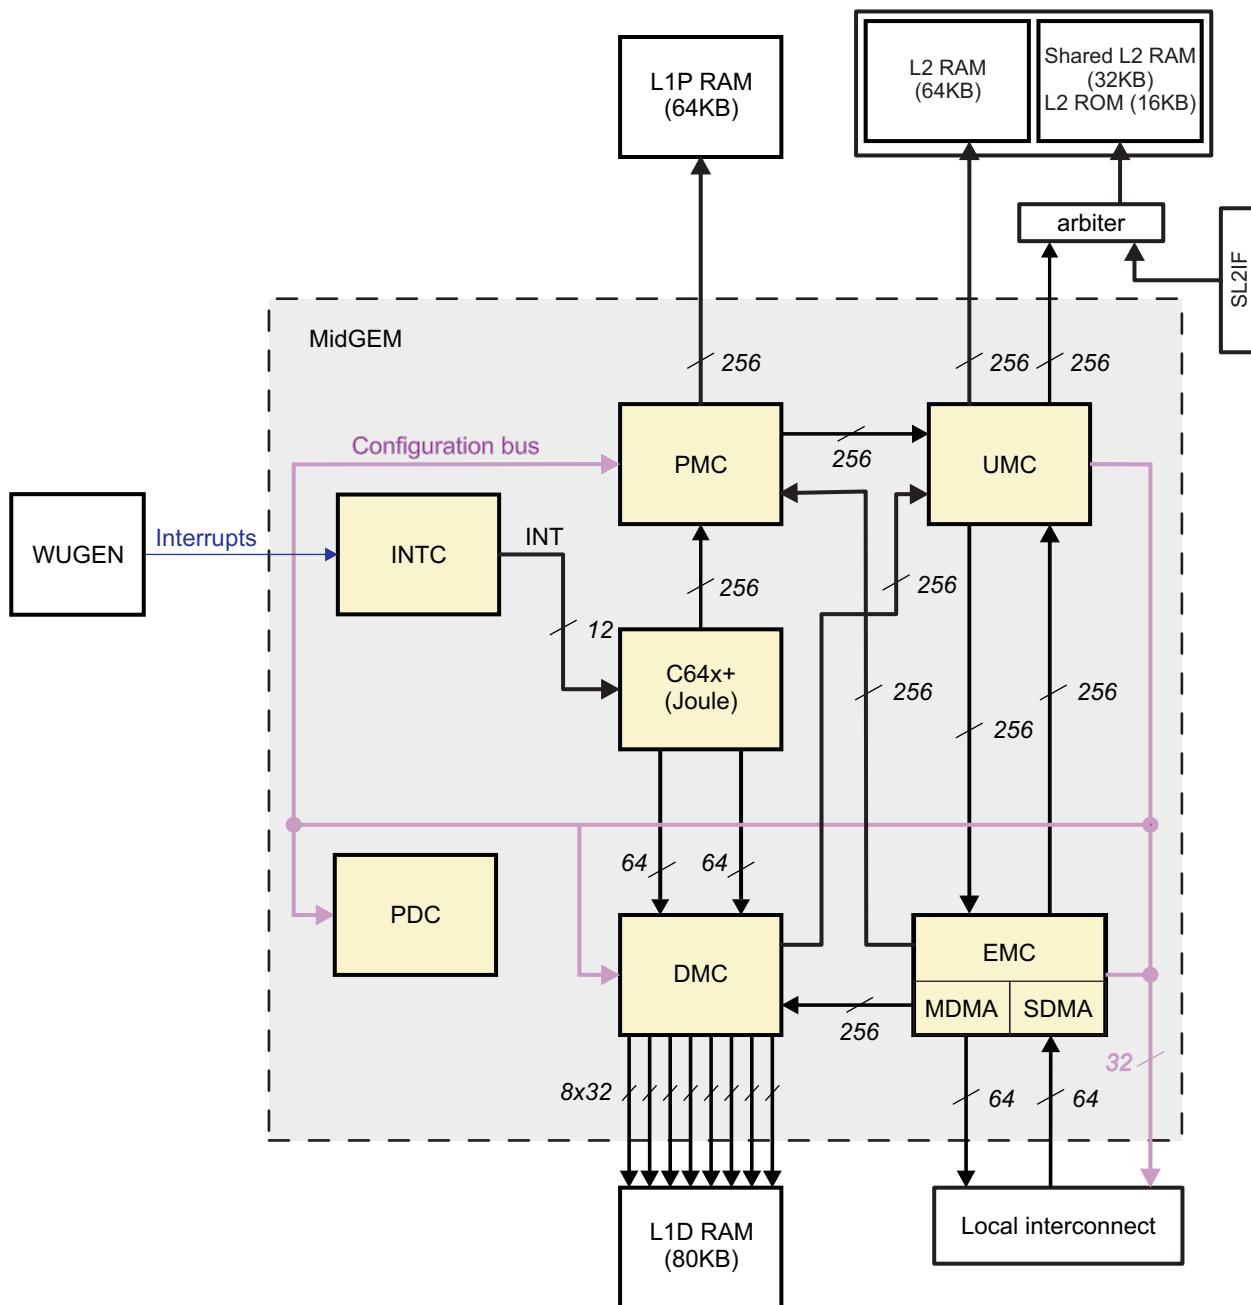
Figure 13. C64x+ Megamodule Block Diagram

The C64x+ Megamodule in the IVA2.2 subsystem has a Master Direct Memory Access (MDMA) bus interface and a Slave DMA (SDMA) bus interface (see [Figure 13](#)). The MDMA interface provides DSP access to resources outside the C64x+ Megamodule such as external DDR memory, flash memory, and On-chip Memory (OCM) RAM. The MDMA interface is typically used for C64x+ CPU/cache accesses to memory beyond the Level 2 (L2) memory level. These accesses can be in the form of cache line allocates, write-backs, and non-cacheable loads and stores to/from system memories.

Ideally the MDMA and SDMA/IDMA paths operate independently with minimal interference. Normally MDMA accesses may stall for extended periods of time (clock cycles) due to expected system level delays (e.g. due to bandwidth limitations and/or DDR memory refreshes). However, due to the exception, there are cases where SDMA and/or IDMA accesses to L2/L1 experience an additional/unexpected stall during the normal stalls seen by the MDMA interface. For latency sensitive traffic, the SDMA stall can result in missing real time deadlines.

Note: SDMA/IDMA accesses to L1P/D will not see any unexpected stall if there are no SDMA/IDMA accesses to L2 (both cache/SRAM and shared SRAM). This is because unexpected SDMA/IDMA stalls to L1 happen only when they are pipelined behind L2 accesses which experience stalls due to the exception.

In the following scenarios, SDMA/IDMA stalls may possibly occur. Note that each of these scenarios describes expected normal DSP functionality. The only issue is that the SDMA/IDMA access potentially exhibits additional unexpected stalling during each of these scenarios:
