**TMS320F28030, TMS320F28031,
TMS320F28032, TMS320F28033,
TMS320F28034, TMS320F28035 Piccolo MCU**

Silicon Errata

Literature Number: SPRZ295J
April 2009–Revised February 2012

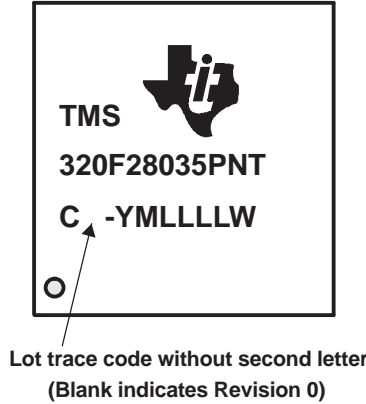
Figure 1. Example of Device Markings

Figure 1 provides an example of the 2803x device markings and defines each of the markings. The device revision can be determined by the symbols marked on the top of the package as shown in Figure 1. Some prototype devices may have markings different from those illustrated. Figure 2 shows the device nomenclature.

Table 1. Determining Silicon Revision From Lot Trace Code (2803x Devices)

SECOND LETTER IN PREFIX OF LOT TRACE CODE	SILICON REVISION	REVISION ID (0x0883)	COMMENTS
Blank (no second letter in prefix)	Indicates Revision 0	0x0000	This silicon revision is available as TMX.
A	Indicates Revision A	0x0001	This silicon revision is available as TMS.
